## Monitoring slope creep motion using multi-temporal interferometry synthetic aperture radar in Semarang, Indonesia

InSAR, Semarang City, slope creep

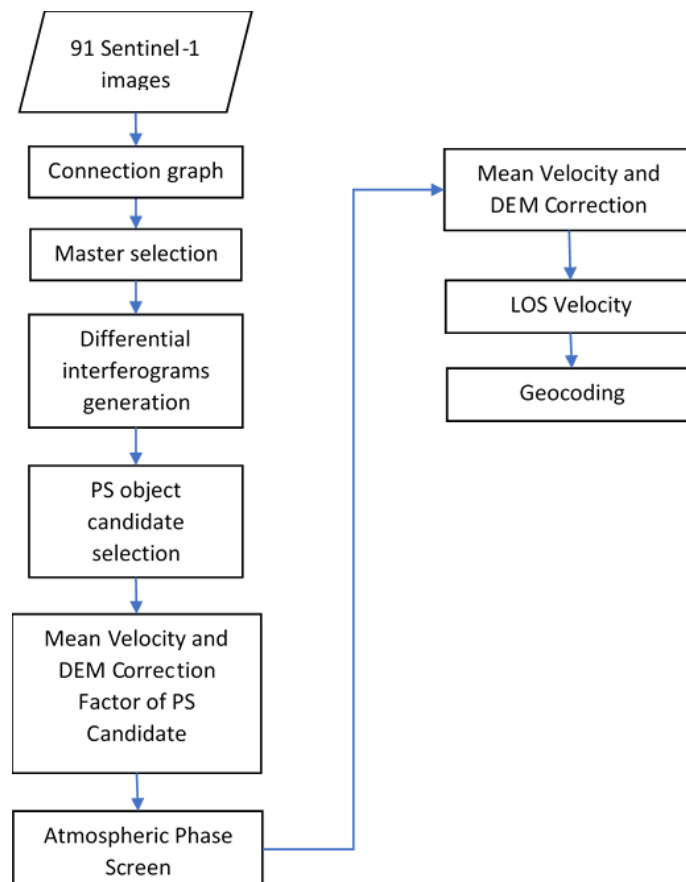
Figure 2 Flowchart of secondary data processing using sentinel 1A/1B

The data was processed using the Persistent Scatterers Interferometry Synthetic Aperture Radar method, abbreviated as PS-InSAR, which refers to Ferretti *et al.*, 2001. The processing result is shown as a displacement time series, where the LOS (Line of Sight velocity) velocity of each PS (Persistent Scatterers) displacement series shows surface deformation.

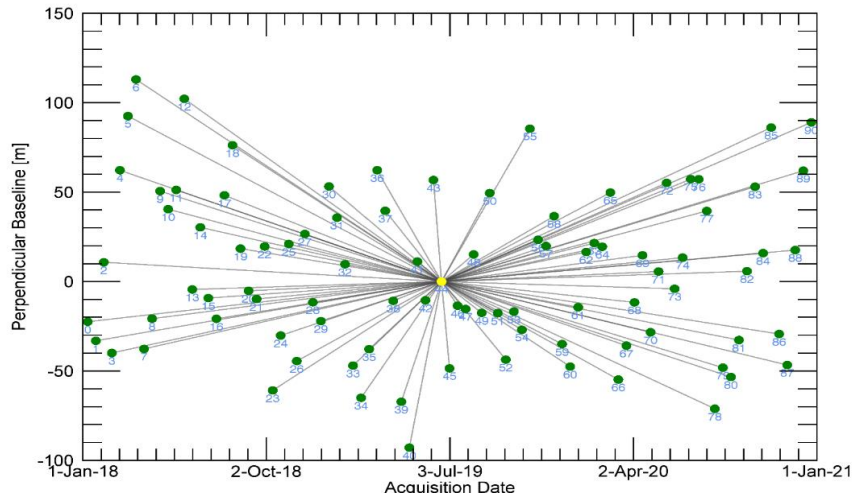
Figure 3 Perpendicular Baseline for PS-InSAR on January, 8<sup>th</sup> 2018 to December 23<sup>rd</sup> 2020

Sentinel 1 satellite imagery has very few descending recordings in the Semarang area, so the image used is an ascending Sentinel 1A image. A total of 91 were used in PS-InSAR processing. The master image used is the result of recording on 20 June 2019 where the highest perpendicular baseline is 112 994 m for the master image used and the coherence threshold used is 0.75 and the area with coherence below 0.75 cannot be estimated.

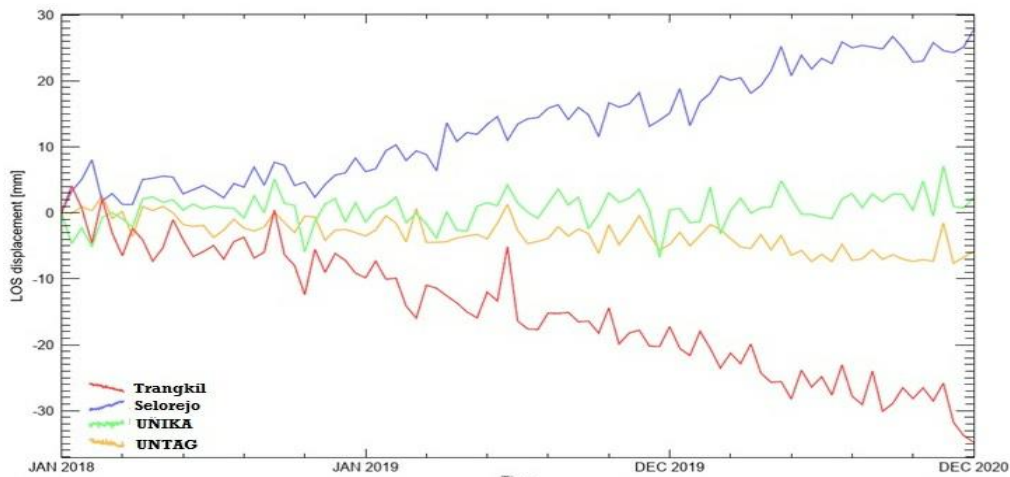
Figure 5 LOS Displacement Trangkil (red line ), Selorejo (blue line), UNIKA (green line), and UNTAG (yellow line)

PS-InSAR can estimate the slope movement in the study area by 40.39%. Based on the LOS speed map in Figure 4, massive slope movement is shown on the area of the road west of PTS now which is relatively away from the LOS direction (point A). Other than PTS, in the same year, slope movement was detected on the housing area of Jalan Selorejo (west of the UNIKA campus) which leads closer to the LOS direction (point B). But the results of this processing did not detect any slope movement on the UNIKA campus (point C) and UNTAG (point D). The average LOS Displacement (Figure 5) for PTS is -9.85 cm/year, and Selorejo is 9.32 cm/year.

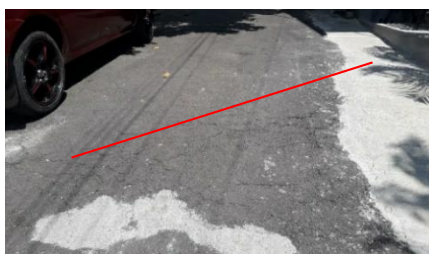
(a) Azimuth Strike: N 260; Coordinate: 0432814, 9222473

Figure 6 a-j Azimuth strike and creep failure moves (red line)

Field surveys were carried out with measuring moves on scarp or creep failure (Figure 6), and documentation process in the research area, including: (1) Trangkil Sejahtera Housing. From the survey results, the moves from the minor scarp which show continuity on Trangkil Sejahtera Housing with azimuth moves between N 300 (PTS 03), N 270 (PTS 04), and N 300 (PBS 01). This is thought to be related to the landslide that occurred in Trangkil Baru in 2014; (2) UNIKA and UNTAG University. Based on the LOS Map as a result of secondary data processing, the UNIKA campus and UNTAG campus did not detect any creep slope movement from 2018 to 2020, but in the end, there was some evidence of slope movement; (3) Selorejo-Tinjomoyo. Based on the LOS map resulting from secondary data processing, it was observed that slope movements in the Selorejo and Tinjomoyo areas, Gajahmungkur District (west of UNIKA). The survey results show the azimuth moves in these two areas range from N 135 to N 150.

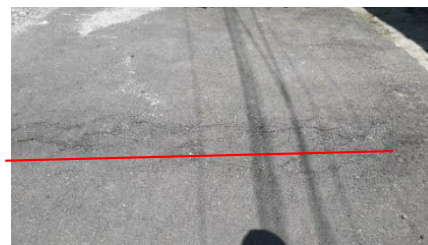
(b) Azimuth Strike: N 240; Coordinate : 0432806, 9222535

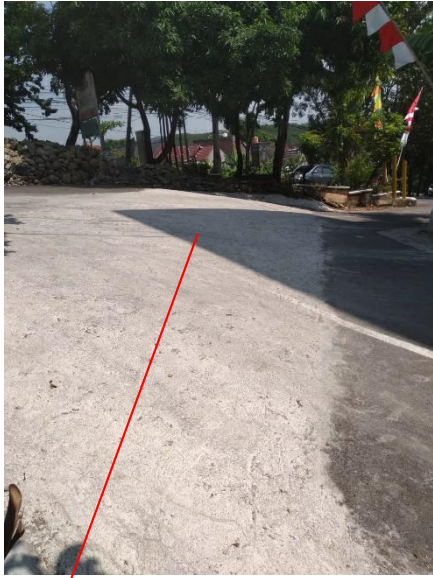
(c) Azimuth Strike: N 300  
Coordinate: 432763, 9222545

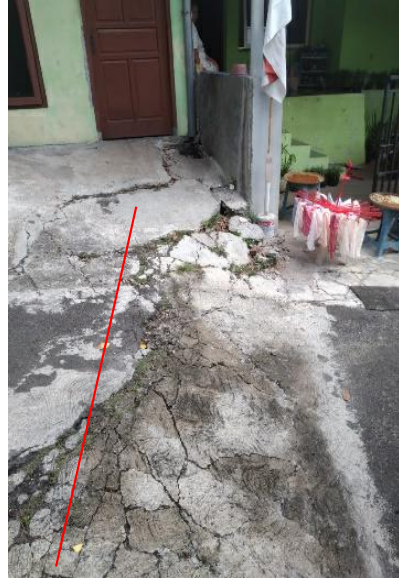
(d) Azimuth Strike: N 270  
Coordinate: 432884, 9222488

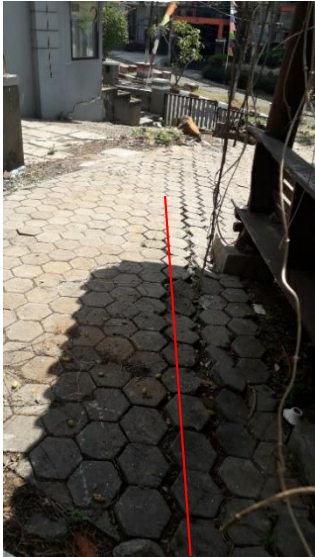
(e) Azimuth Strike: N 280  
Coordinate: 0432706, 9222577

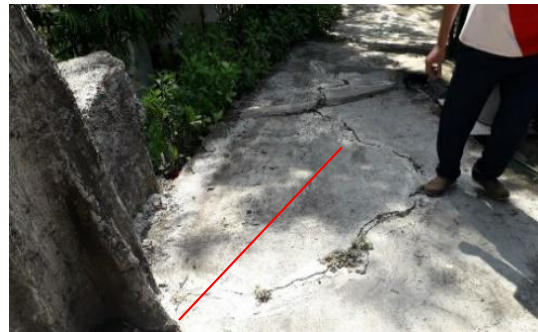
(f) Azimuth Strike: N 135  
Coordinate: 433818, 9223415

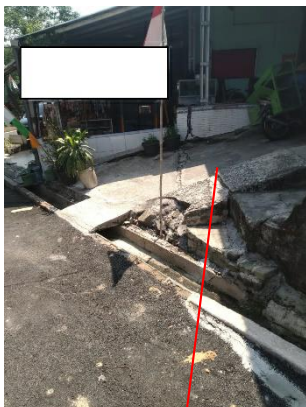
(g) Azimuth Strike: N 130  
Coordinate: 433828, 9223334

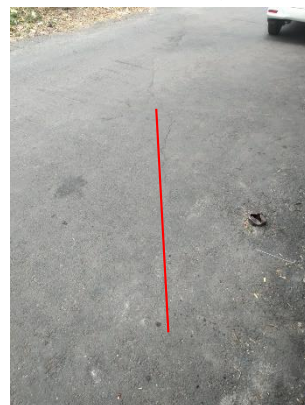
(h) Azimuth Strike: N 150  
Coordinate: 434032, 9223468

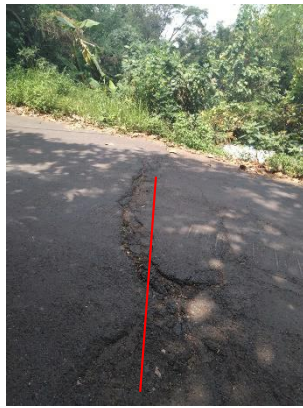
(i) Azimuth Strike: N 150  
Coordinate: 433972, 9223303

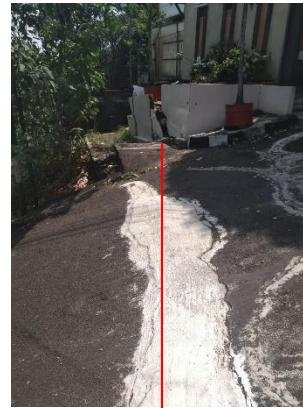
(j) Azimuth Strike: N 140  
Coordinate: 433973, 9223404
